Iconic Sandton building gets a facelift

3 Alice Lane

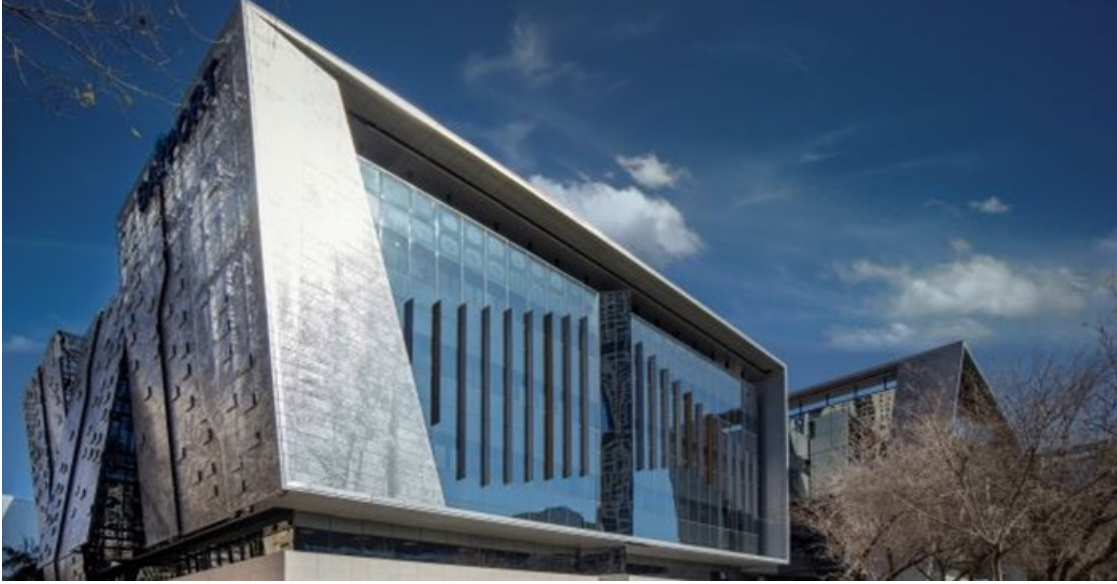
“The new façade consists of a full glass wrap of the building with a ventilated tiling system cladding the ground floor. The east elevation facing Alice Lane features a perforated aluminium screen with a design of trees in the panelling. Blue LED lights backlight the screen to highlight the perforated design at night.”

The north elevation was divided into three sections with an eyebrow, wing cladding and a tongue frame highlighting these. All three sections were constructed of powder-coated aluminium to fit in with the design aesthetic of the suburb.
